EXHIBIT D

Review of CT scans of subject Sig Sauer P-320's and further
examination of Exemplars

This report is for the examination of three “exemplar” Sig Sauer model P-320 handguns and two subject P-320 in evidence to determine possible manufacturer defects in design.

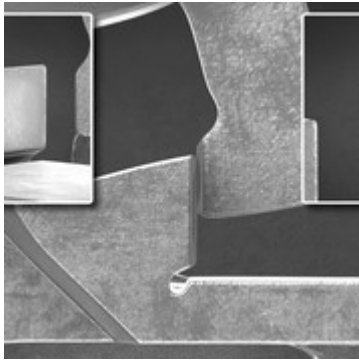
Striker foot to sear engagement showing “rollover” condition causing minimal contact between both parts.

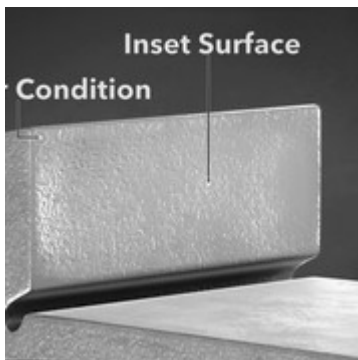
Sear face showing rollover around edges

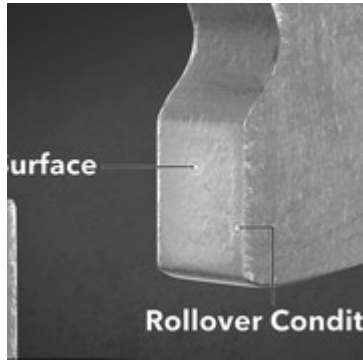
Striker foot surface showing rollover condition

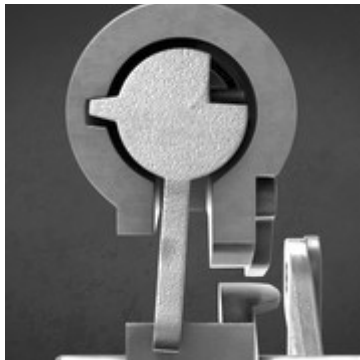
- 4) (DESIGN DEFECT) A rear view of the striker foot channel in the slide showed an excessive gap vertically along the striker foot which allows the striker to have excess lateral movement within the channel from left to right causing the striker foot to not only make an improper connection to the sear, but also can cause the safety lock tab that makes contact with the parallel horizontal plain of the striker to be out of alignment.

- 5) This misalignment could cause minimal contact between the safety lock tab and the rear vertical portion of the striker,which in turn can cause the safety lock tab to ride over the striker causing an uncommanded discharge as it moves upwards.

Rear view of striker foot showing excess lateral movement which causes inconsistent interaction of safety lock tab and sear face.

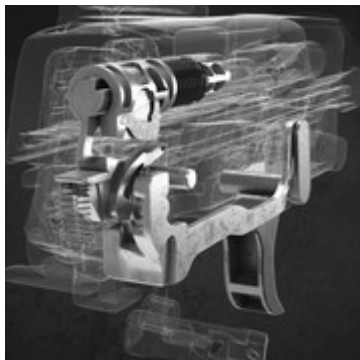
- 14) (DESIGN DEFECT) I also noticed in the CT scans of all four subject P-320's that the vertical alignment of the striker foot was farther to the left rather than being designed to be positioned directly over the center of the sear and springs. This misalignment can contribute to the lack of even spring pressure and the proper rise of the sear. Uneven spring pressure can result in the sear being able to also move slightly diagonally within its vertical channel.

Rear view of striker foot off center of sear face
